Flood Control Project Maintenance
2012 Structure Summary Report
Overall Unit and Item Ratings

City of Sacramento

El Camino Avenue Bridge

Magpie Creek Pumping Plant

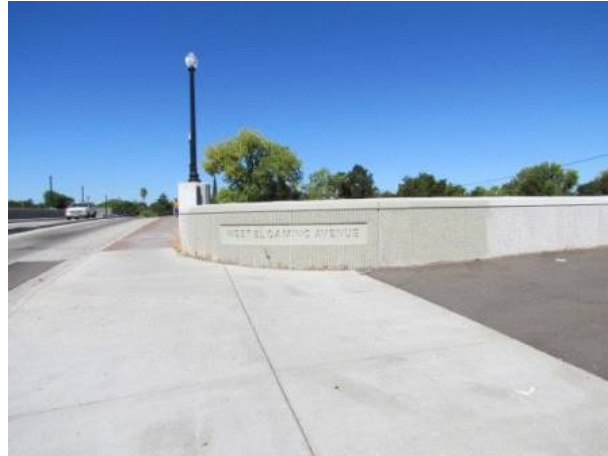
pkazi_t_20120828_228.JPG

View of the flood wall.

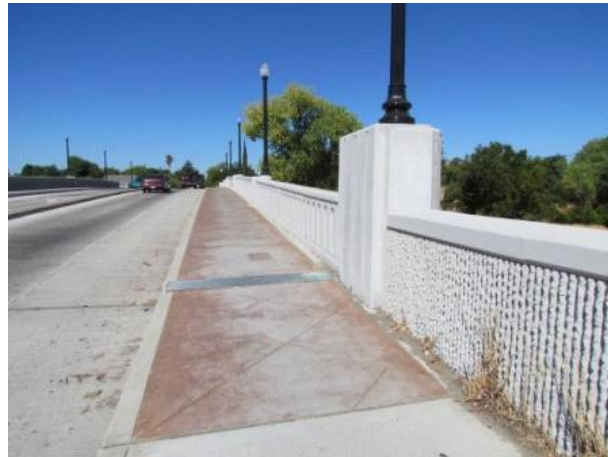
pkazi_t_20120828_229.JPG

View of the flood wall.

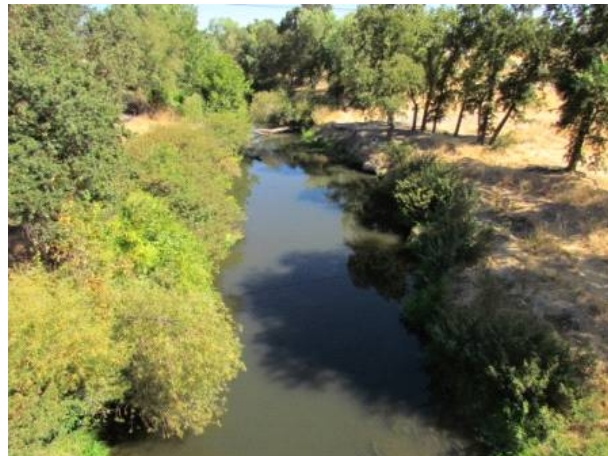
pkazi_t_20120828_230.JPG

View of the channel under the bridge.

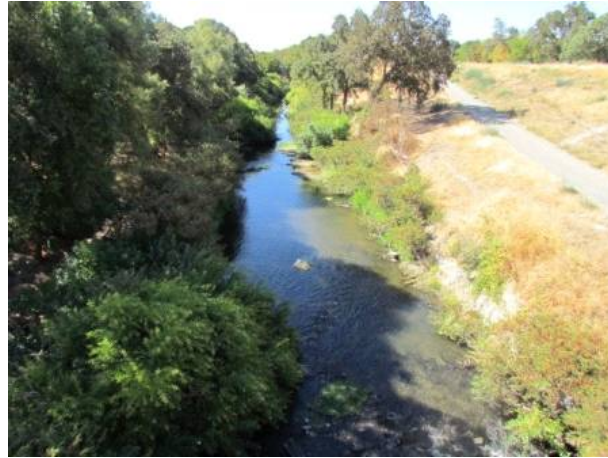
Levee Mile Report Line	4
Start Levee Mile	0.00
End Levee Mile	0.00
Location	
Category	Structures
Item	Erosion / Bank Caving
No erosion was found on the channel bank below the bridge.	
pkazi_t_20120828_231.JPG

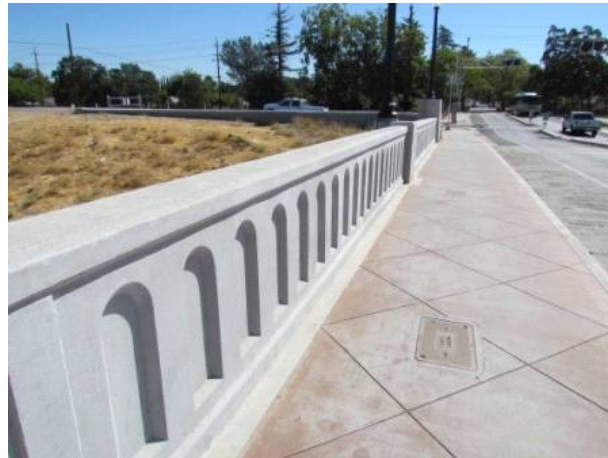
Levee Mile Report Line	15
Start Levee Mile	0.00
End Levee Mile	0.00
Location	
Category	Structures
Item	Concrete Surfaces
View of the flood wall.	
pkazi_t_20120828_232.JPG

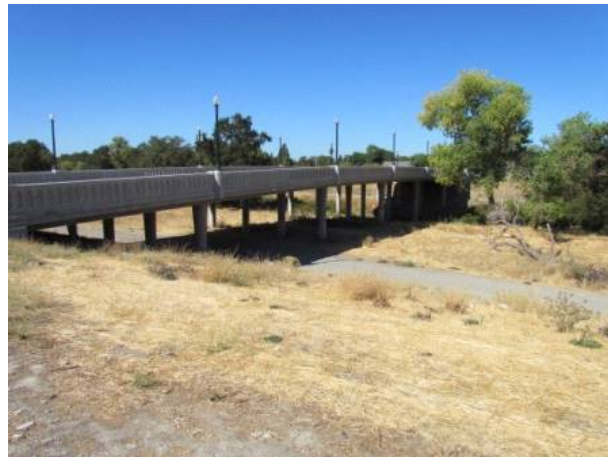
Levee Mile Report Line	17
Start Levee Mile	0.00
End Levee Mile	0.00
Location	
Category	Structures
Item	Concrete Foundations
View below of the bridge.	
pkazi_t_20120828_233.JPG

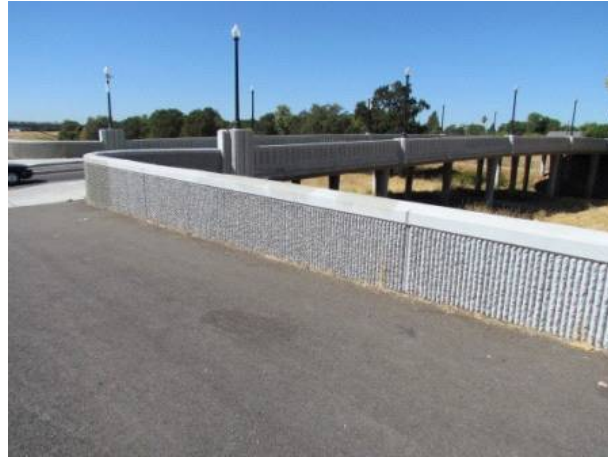
Levee Mile Report Line	22
Start Levee Mile	0.00
End Levee Mile	0.00
Location	
Category	Structures
Item	Monolith Joints
View of the flood walls with monolith joints.	
pkazi_t_20120828_234.JPG

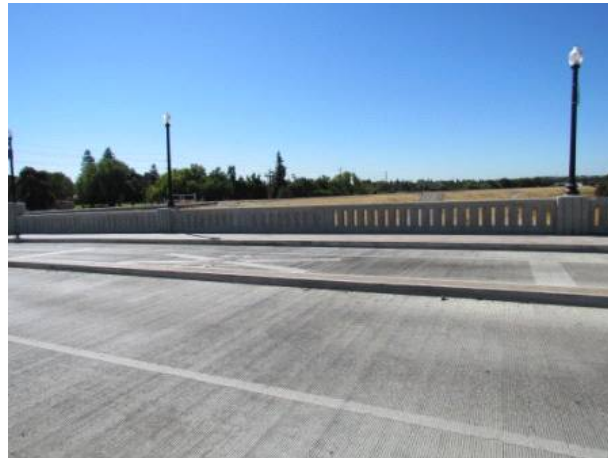
Levee Mile Report Line	22
Start Levee Mile	0.00
End Levee Mile	0.00
Location	
Category	Structures
Item	Monolith Joints
View of the flood walls with monolith joints.	
pkazi_t_20120828_235.JPG

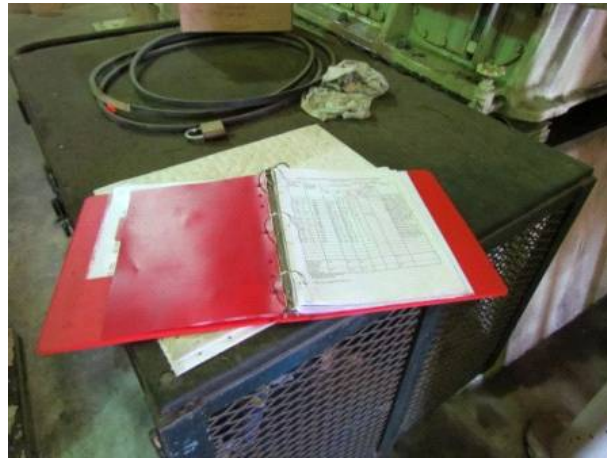
pkazi_t_20120828_210.JPG

View of the maintenance log inside the pumping plant.

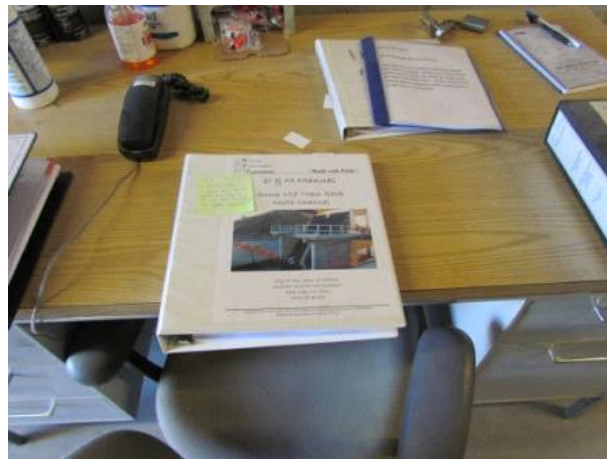
pkazi_t_20120828_211.JPG

View of the O&M manual in the pumping plant.

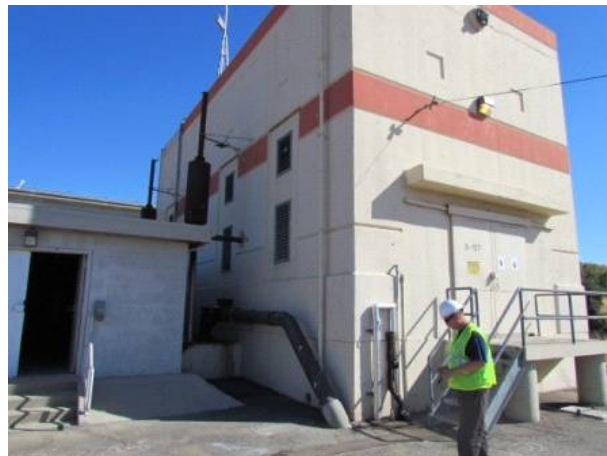
pkazi_t_20120828_212.JPG

View of the pumping plant and the control room.

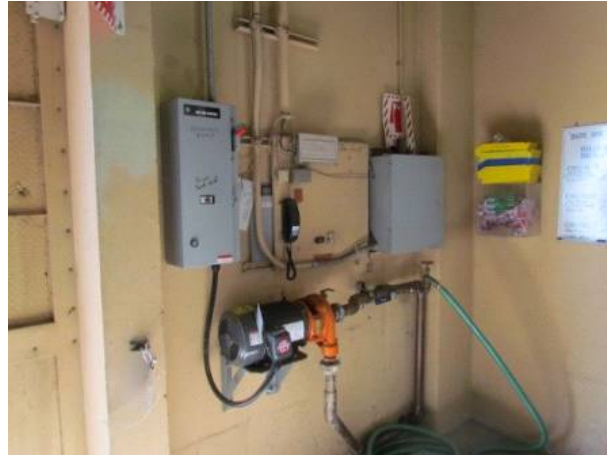
pkazi_t_20120828_227.JPG

View of the phone inside the pumping plant.

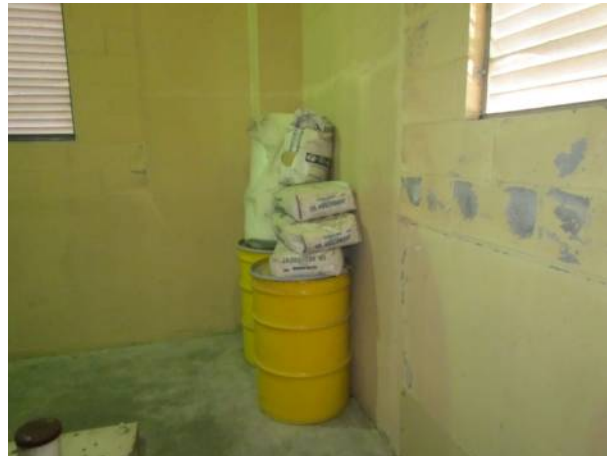
pkazi_t_20120828_213.JPG

Safety material for oil spills was present inside the pumping plant.

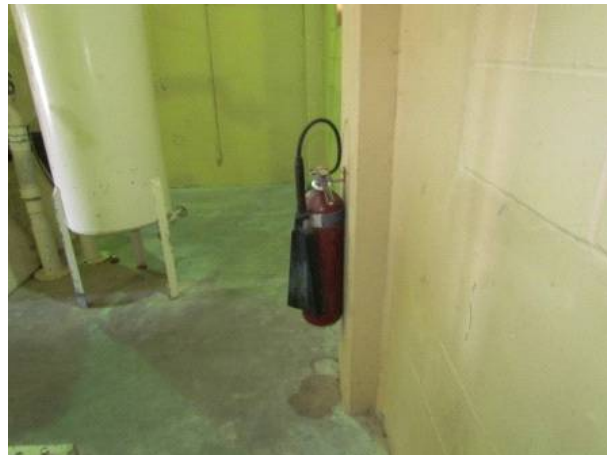
pkazi_t_20120828_214.JPG

View of the fire extinguisher inside the pumping plant.

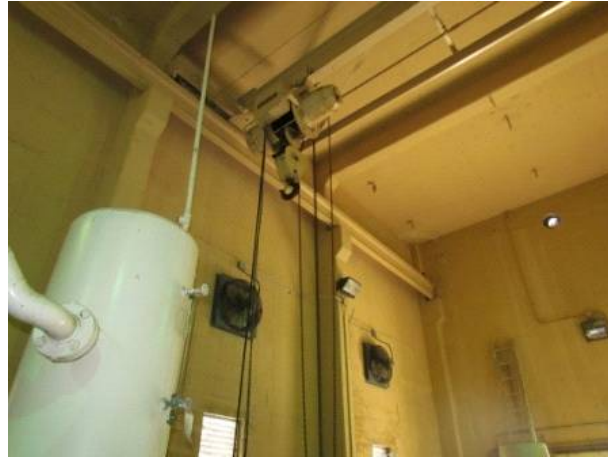
pkazi_t_20120828_215.JPG

View of the crane inside the pumping plant.

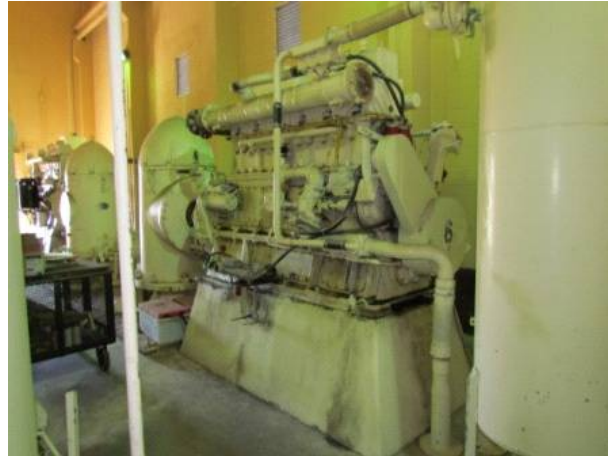
pkazi_t_20120828_216.JPG

View of one of the propane powered pumps inside the plant.

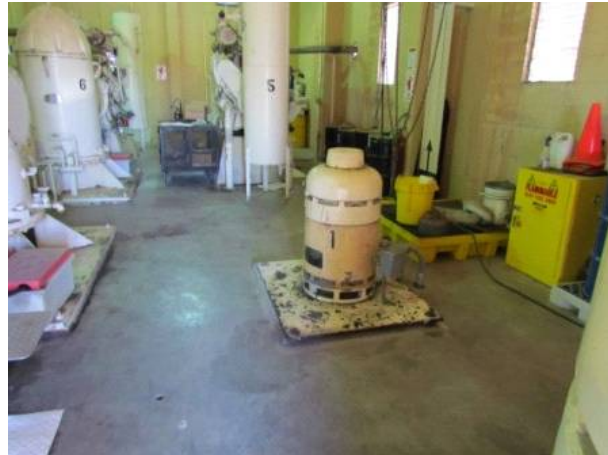
pkazi_t_20120828_217.JPG

View of one of the electric pumps inside the plant.

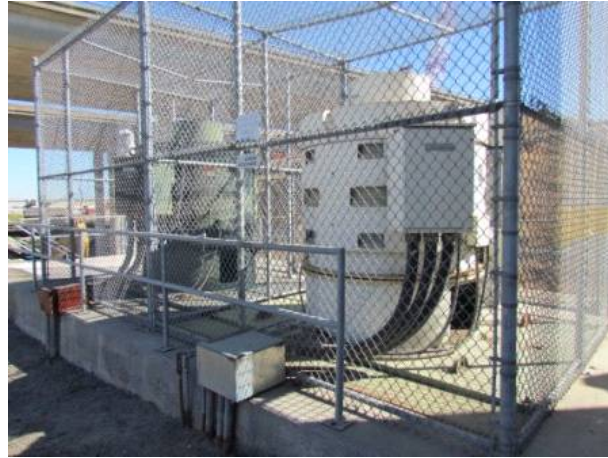
pkazi_t_20120828_218.JPG

View of the pumps outside of the pumping plant.

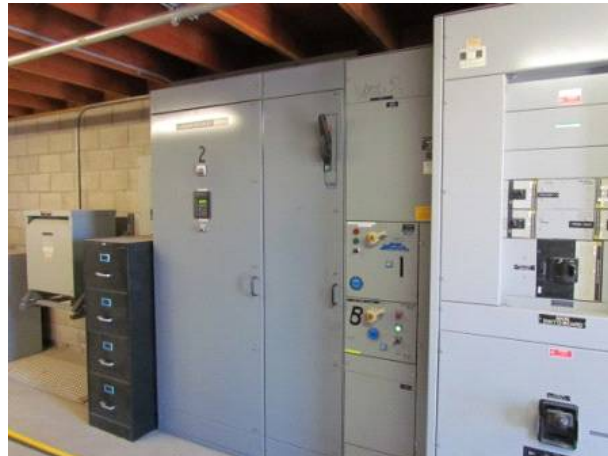
pkazi_t_20120828_219.JPG

View of the pump control systems.

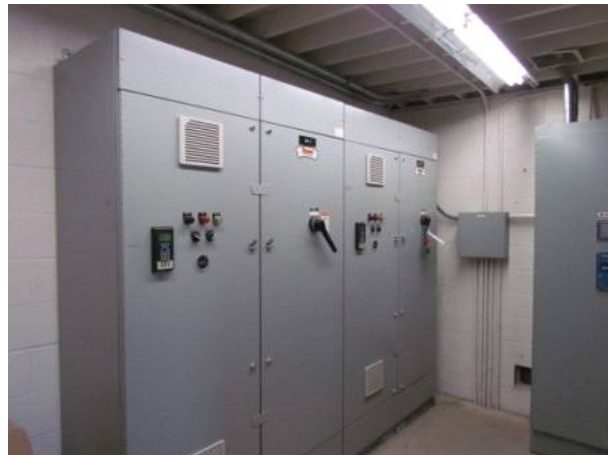
pkazi_t_20120828_220.JPG

View of the pump control systems inside the control building.

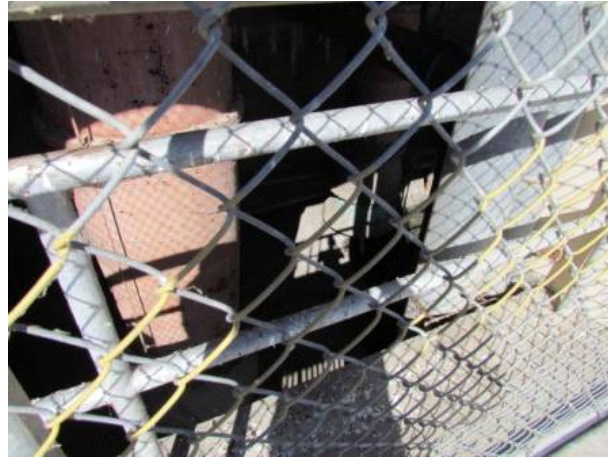
pkazi_t_20120828_221.JPG

View of the wet well below the pumping plant.

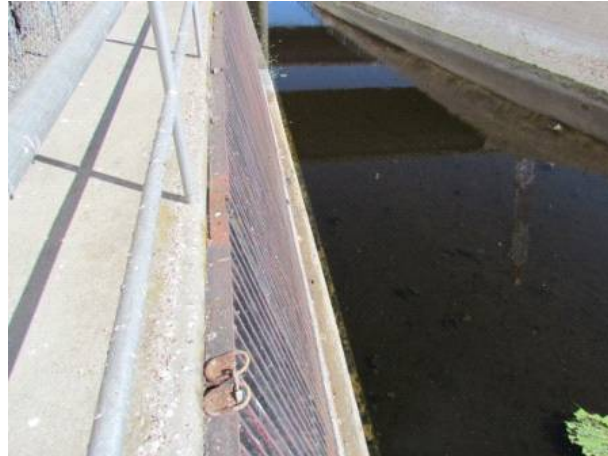
pkazi_t_20120828_222.JPG

View of the trash rack.

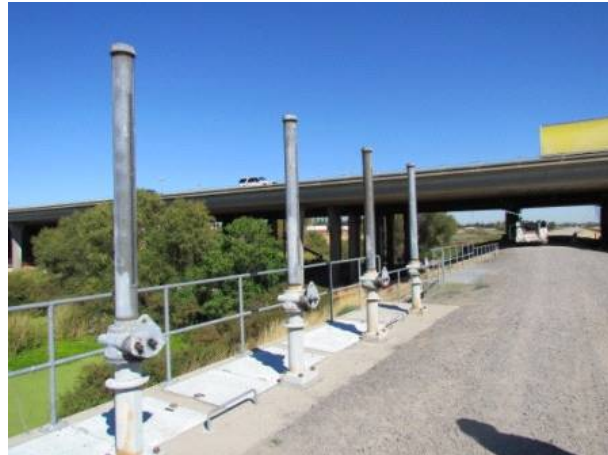
pkazi_t_20120828_223.JPG

View of the slide gate operators.

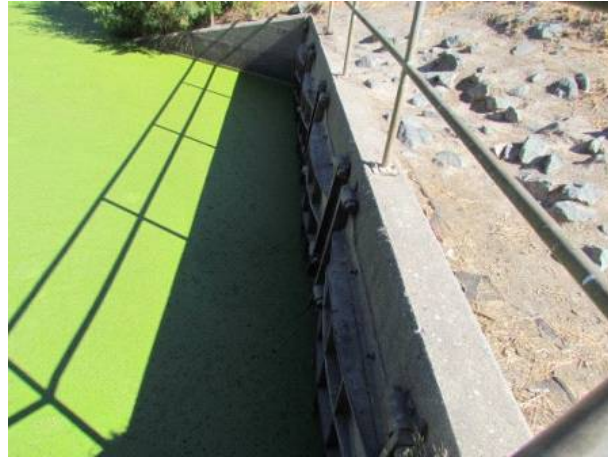
pkazi_t_20120828_224.JPG

View of the flap gates.

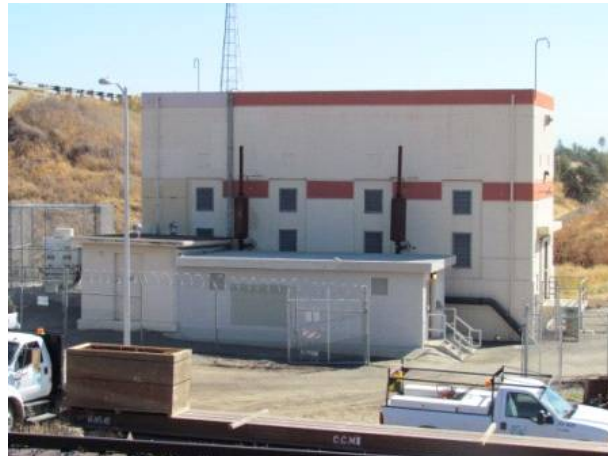
pkazi_t_20120828_225.JPG

View of the security fencing around the structure.

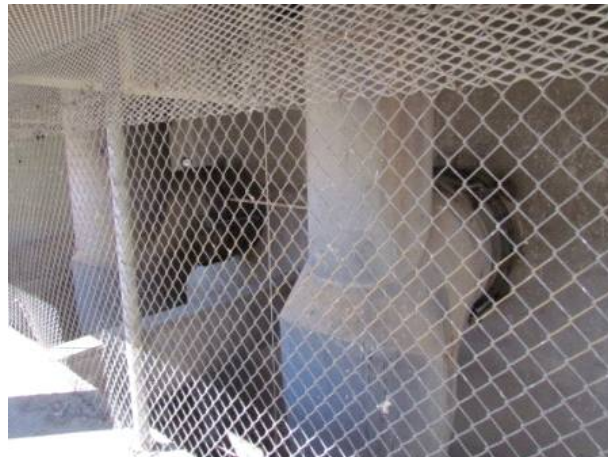
pkazi_t_20120828_226.JPG

View of the intake pipes.
